HEADQUARTERS
70TH ENGINEER BATTALION (COMBAT)(ARMY)
APO 96294

SUBJECT: Operational Report-Lessons Learned (RCS CSFOR-65), for Quarterly Period Ending 31 Oct 66.

SUBJECT: After Action Report - Golf Course Airstrip

SUBJECT: After Action Report - Golf Course Airstrip Repair

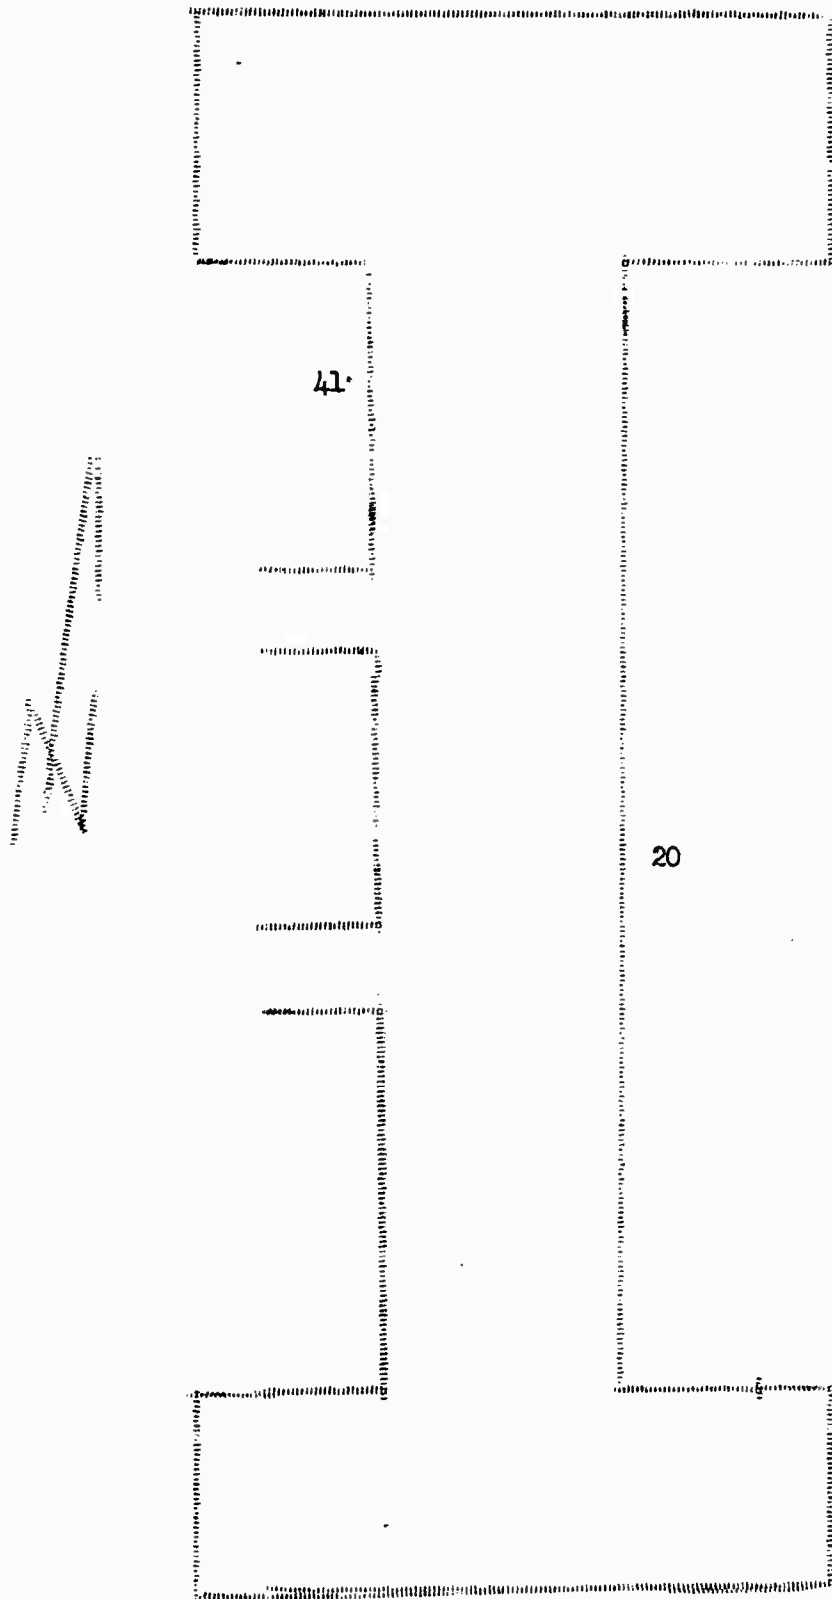
GOLF COURSE AIRSTRIP

a. Inspection of the existing runway disclosed that the southern 1000 feet was rutted badly. The average depth of these ruts was 10-12 inches. The existing CBR was 0-2 and in many areas the sub base was saturated. The north taxiway had a CBR of 0 and was completely untrafficable. The parking apron had many soft spots and was receiving runoff from the runway due to poor drainage in the area between the runway and parking apron.

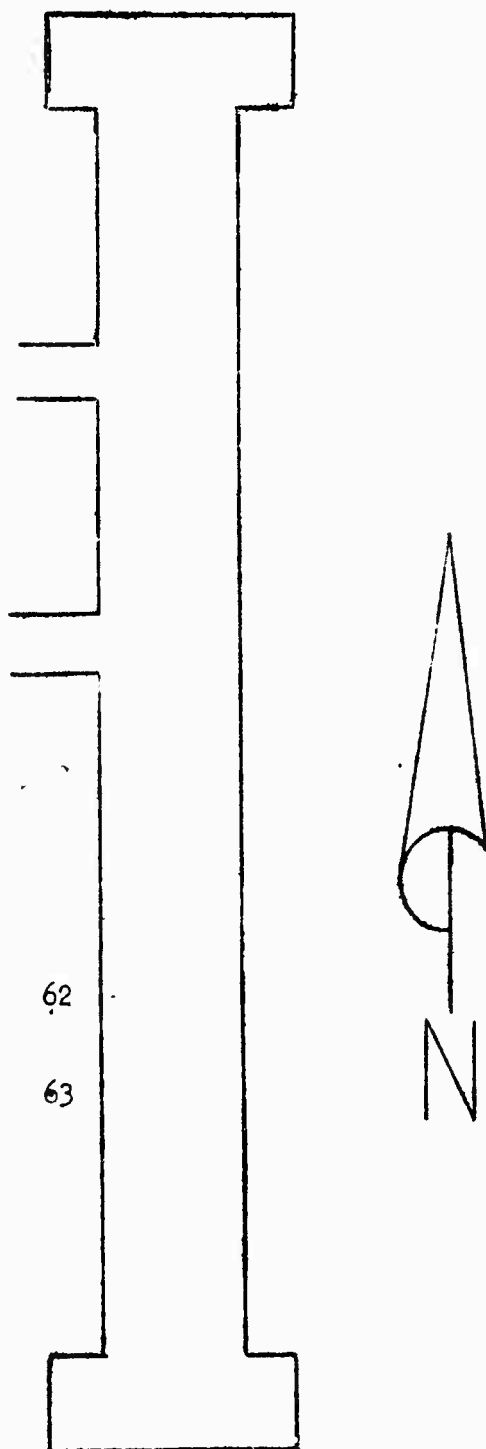
GOLF COURSE AIRSTRIP

1. General: On 19 Sep 66 a pumping action was observed at station #62, (see inclosed map) on the Golf Course Airstrip. This action at this particular time was confined to mud being forced up through the joints in the AM-2 matting. In as much as this was an isolated case and the AM-2 matting did not appear to be undergoing any damage it was decided to have this section monitored closely and keep the airfield open. On 30 Sep 66, personnel observing this area noted that the AM-2 matting was becoming deformed. The area undergoing a deformation process encompassed 1000 sq ft and had deflected approximately 2" vertically. The battalion continued to monitor the strip very closely since it could not be closed due to operation Thayer. At 1245 on 7 Oct 66, a hair line crack (sketch A) was observed in the joint of the end panel of the depression. Landing and taxiing of C-130 aircraft over the section where a depression had formed actually caused the AM-2 panels to become disengaged in two separate places. After removing the AM-2 matting and inspecting the sub-grade conditions the disengaging of the panels was attributed to the failure in the sub-grade, which when taxied upon by C-130 Aircraft effected a rippling action in the AM-2. The strip was officially closed as of 1800 hours 7 Oct 66.

- a. 300' of AM-2 matting was removed and salvaged.
- b. 300' of T-17 membrane was removed.
- c. The areas in the subgrade which had failed were refilled, using a sand-cement and soil-cement mix, and compacted.
- d. T-17 membrane and AM-2 matting was replaced.
